**2L Trails**  
**Trail Volunteer Project Report for 2018**  
**Salmon/ Challis National Forest**

## 2L Trails 2018 Volunteer Report, S/CNF

### Williams Creek Trail Project (078) June 1-3, 2018

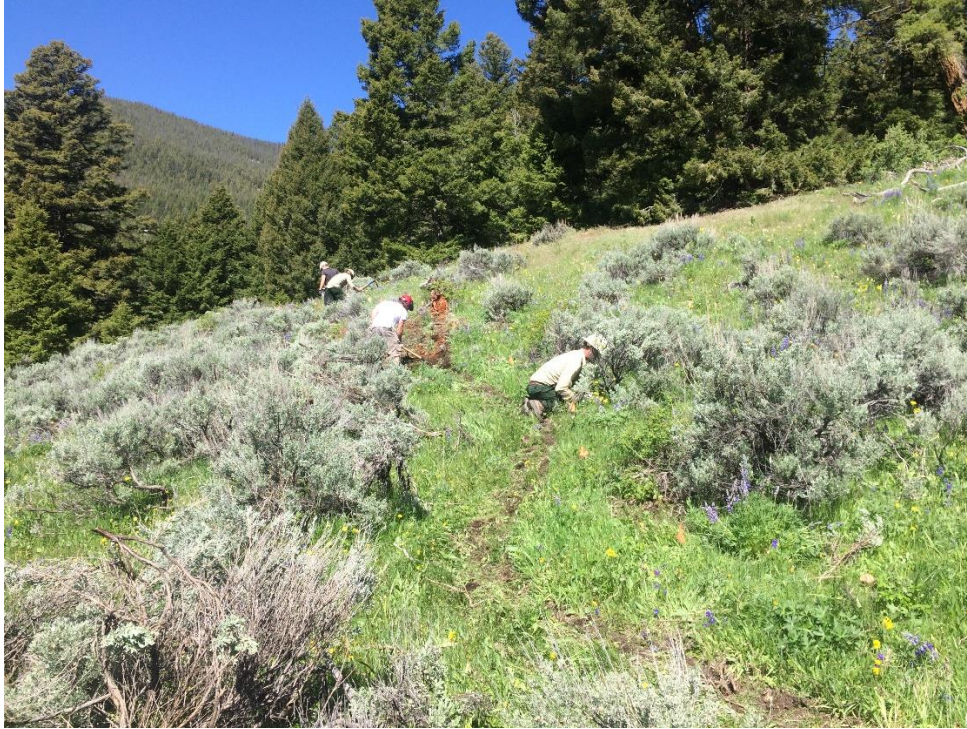
Clearing Vegetation and digging tread.

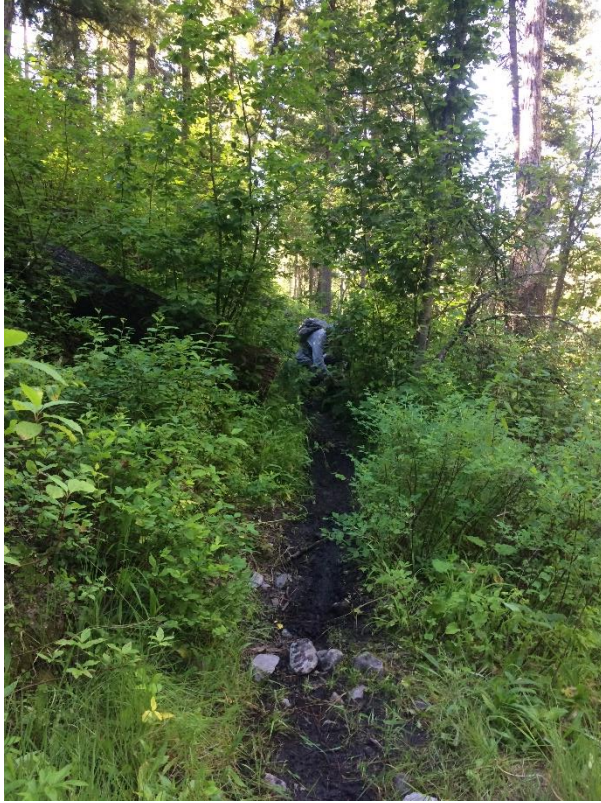
Before

East Fork of Salzer Creek

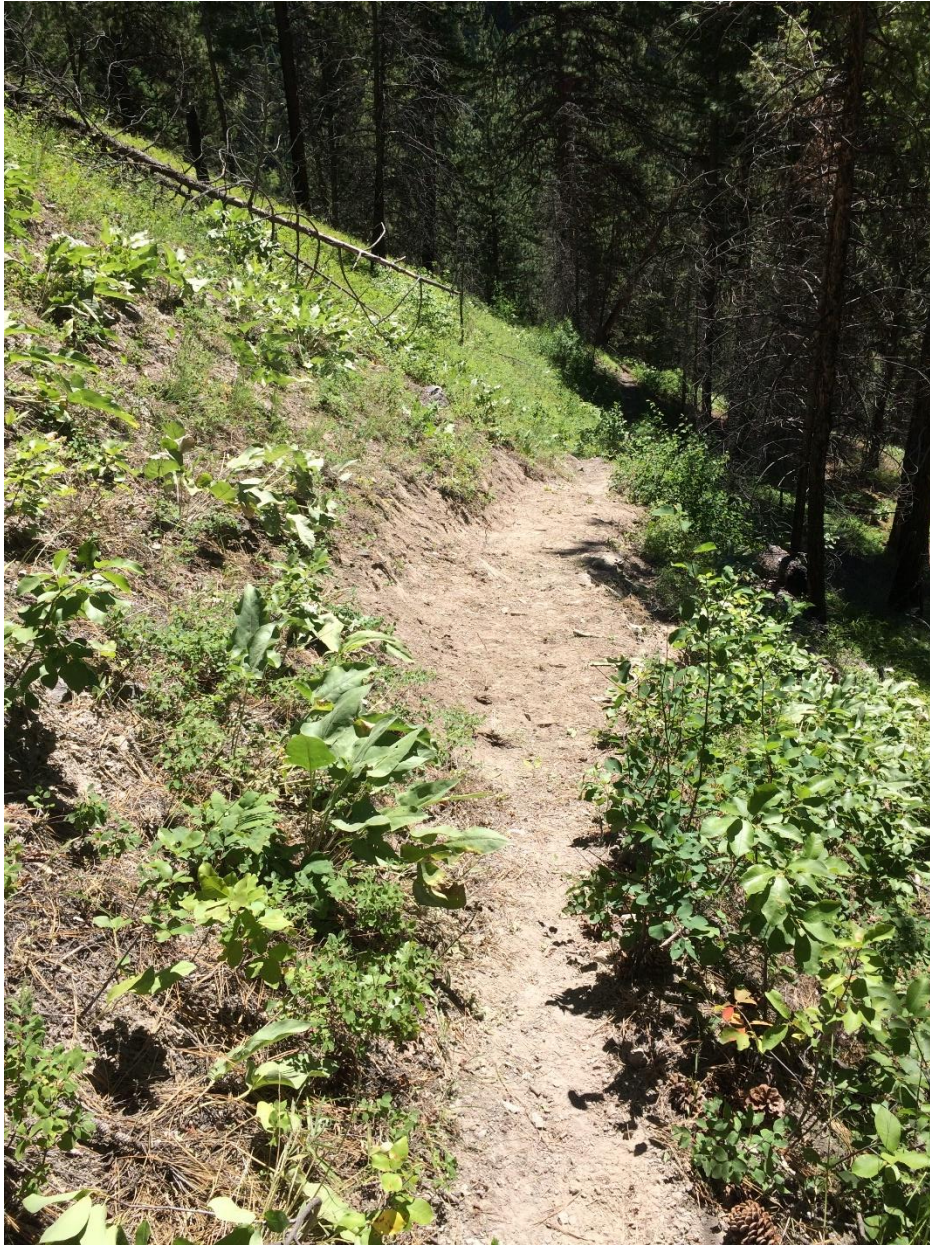
One section of tread repair between West Fork and East Fork of Salzer Creeks. Due to decades of sloughing, the tread bench is narrowing, causing trail users to travel on the berm. In many places the berm is too soft to bare the weight of dirt bikes and pack animals.

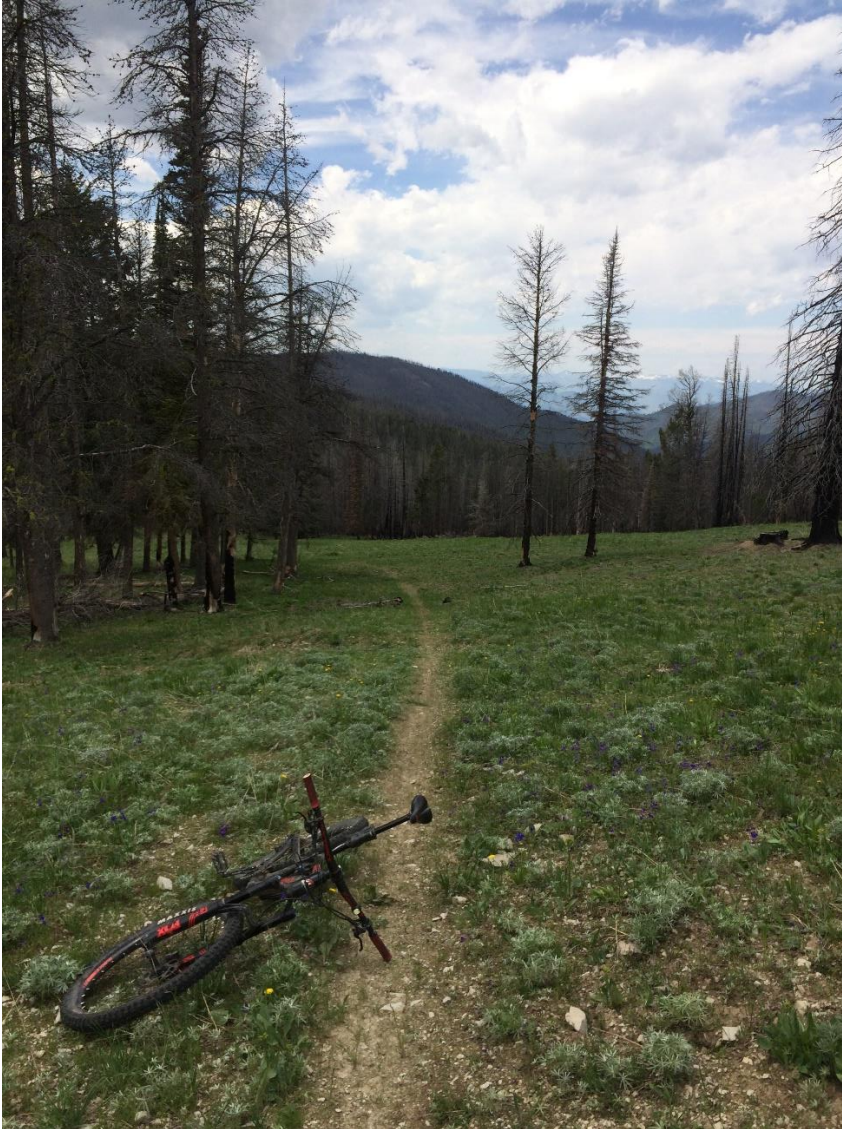
This is the section near Indian Springs. There is a drip drain half way up the meadow. Someday, it will start rutting out. It is recommended that this section is realigned with a side-hill trail rolling turns and drain features.

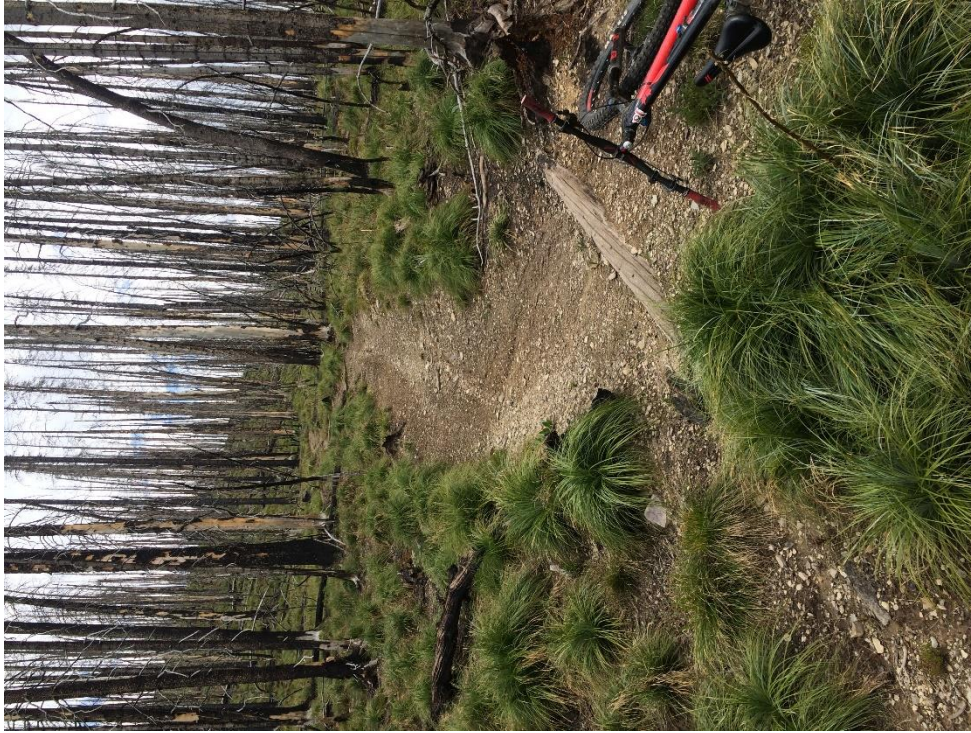
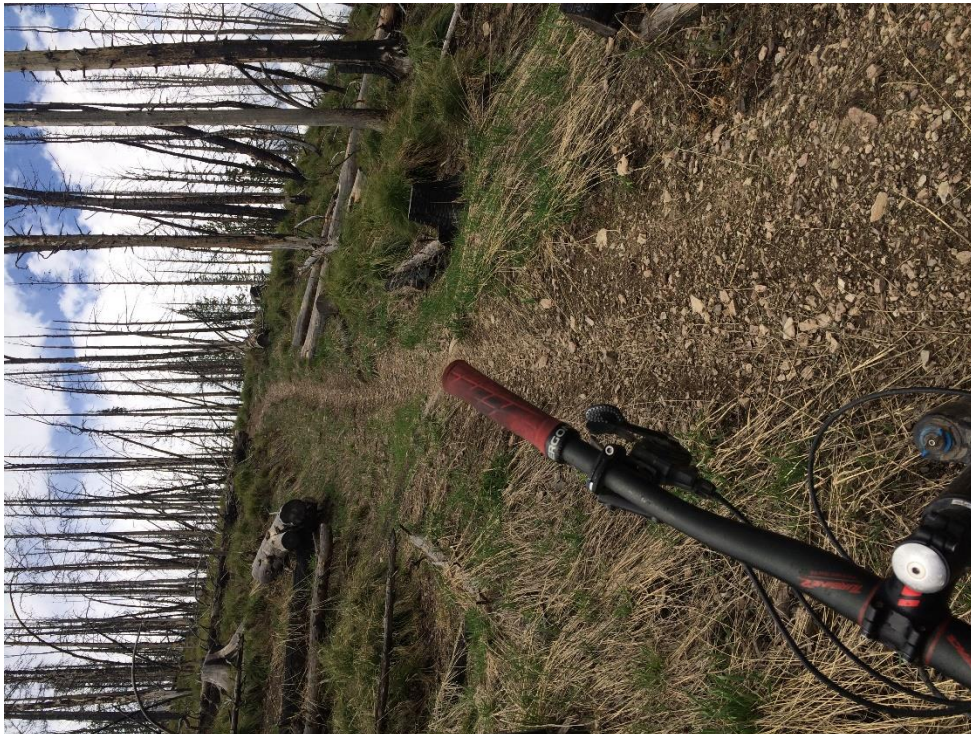
### **Butcherknife Ridge.**

This is the section between Tin Can Springs and the Divide trail. These water-bars have to be cleaned out at least once a year. They fill up with rocks and sediment really fast. Water spills over the tops of the bars when they are full. This section will need to be realigned to eliminate the fall-line and reduce erosion.

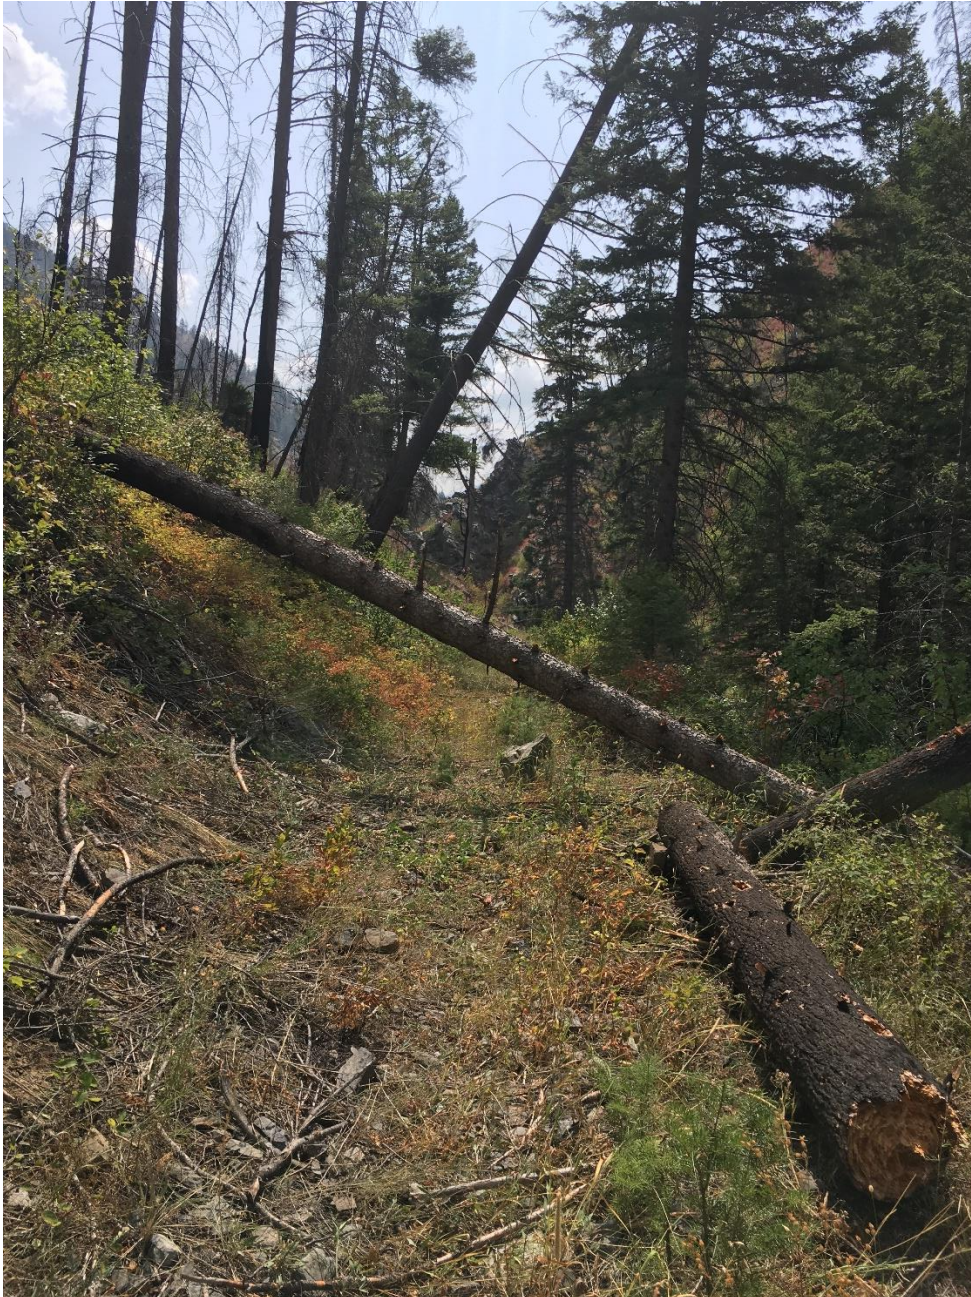
**Henderson Ridge:** This trail has almost disappeared due to the lack of trailhead access. The Indian Creek Road has not been maintained for years. Trying to navigate the length of this trail is almost impossible due to deadfall and thick brush. This trail will need to be located, with the potential to realignment, so old fall-lines can be eliminated and drain features added. If the road to the trailhead is not maintained, it is recommended that it becomes a designated trail for dirt bikes and non-motorized use. This will mean the trailhead will have to be relocated to an easier access.

Before the Mustang Complex Fire in 2012, both Grizzly Springs and Henderson Ridge were encroached with ATV use. Both trails are off limits to ATV travel. There will need to be trail cokes at the trailhead for Grizzly Springs, as well as Henderson Ridge.

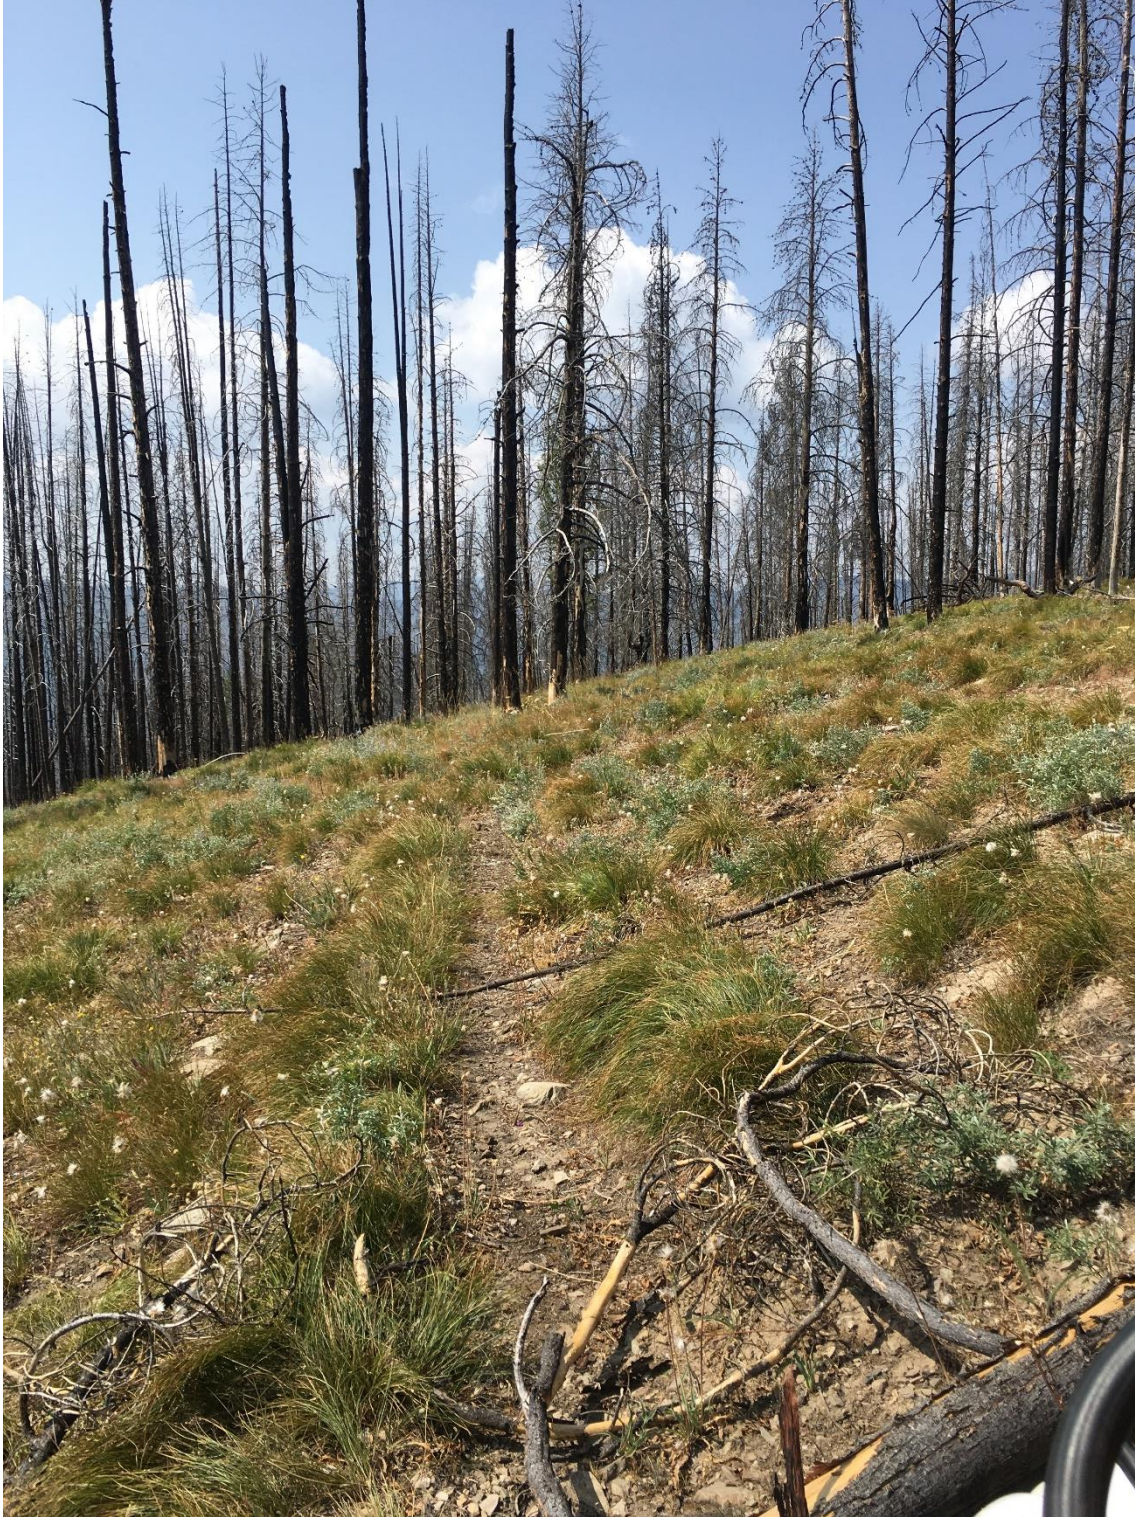
**Henderson Ridge;** old two-track from ATV encroachment.

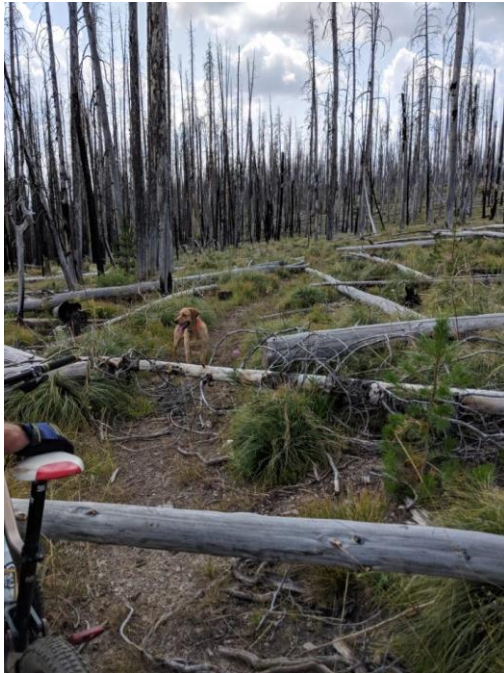
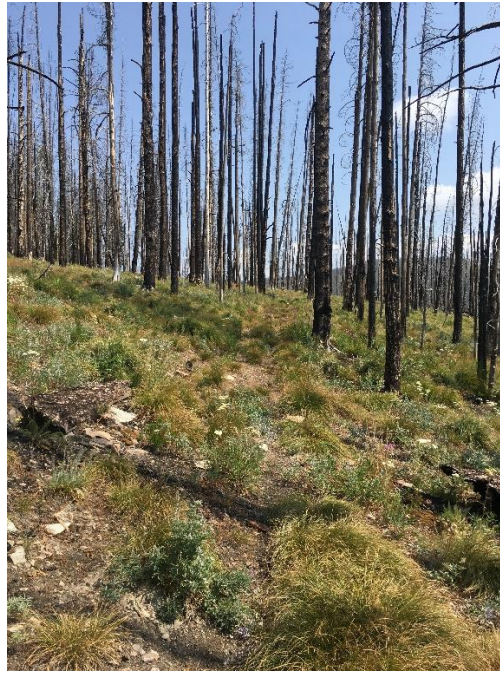
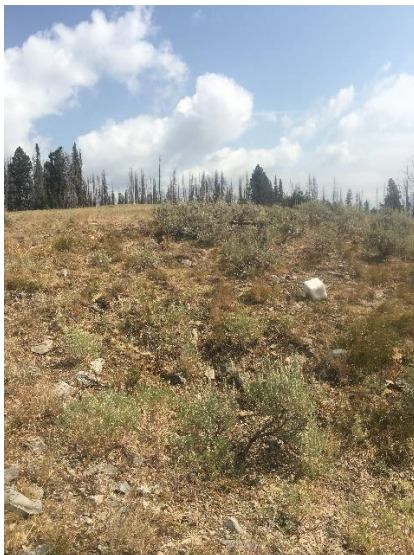
**Grizzly Springs, including Bear Wallow Spring:** This trail is almost lost as well. Without access from the Indian Creek road (FS 036) there is no use. Trying to navigate the length of this trail is almost impossible due to deadfall and thick brush. This trail will need to be located, with the potential of realignment to eliminate old fall-lines and add drain features. If the road to the trailhead is not maintained, it is recommended that it becomes a designated trail for dirt bikes and non-motorized use. Before the Mustang Complex Faire in 2012, both Grizzly Springs and Henderson Ridge were encroached with ATV use. Both trails are off limits to ATV travel. There will need to be trail cokes at the trail head for Grizzly Springs, as well as Henderson Ridge.

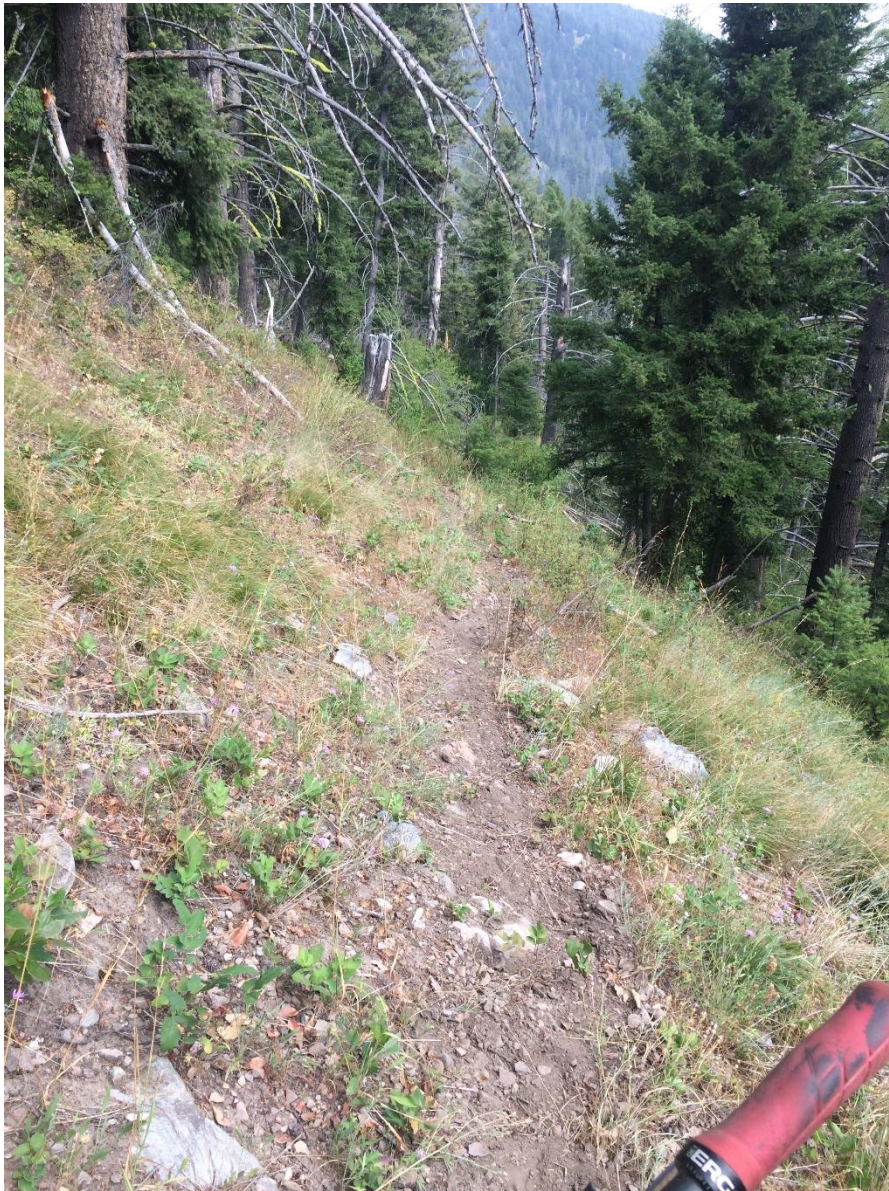
There are sections above the old cabin that are narrow due to “trail-creeping”. This forces users to travel across the berm, which can give out under the hoofs of pack animals. Its recommended that the side-hill trail be re-dug so users can travel on a solid surface. There are about three trail segments that have trail-creeping, totaling about one mile worth of digging.

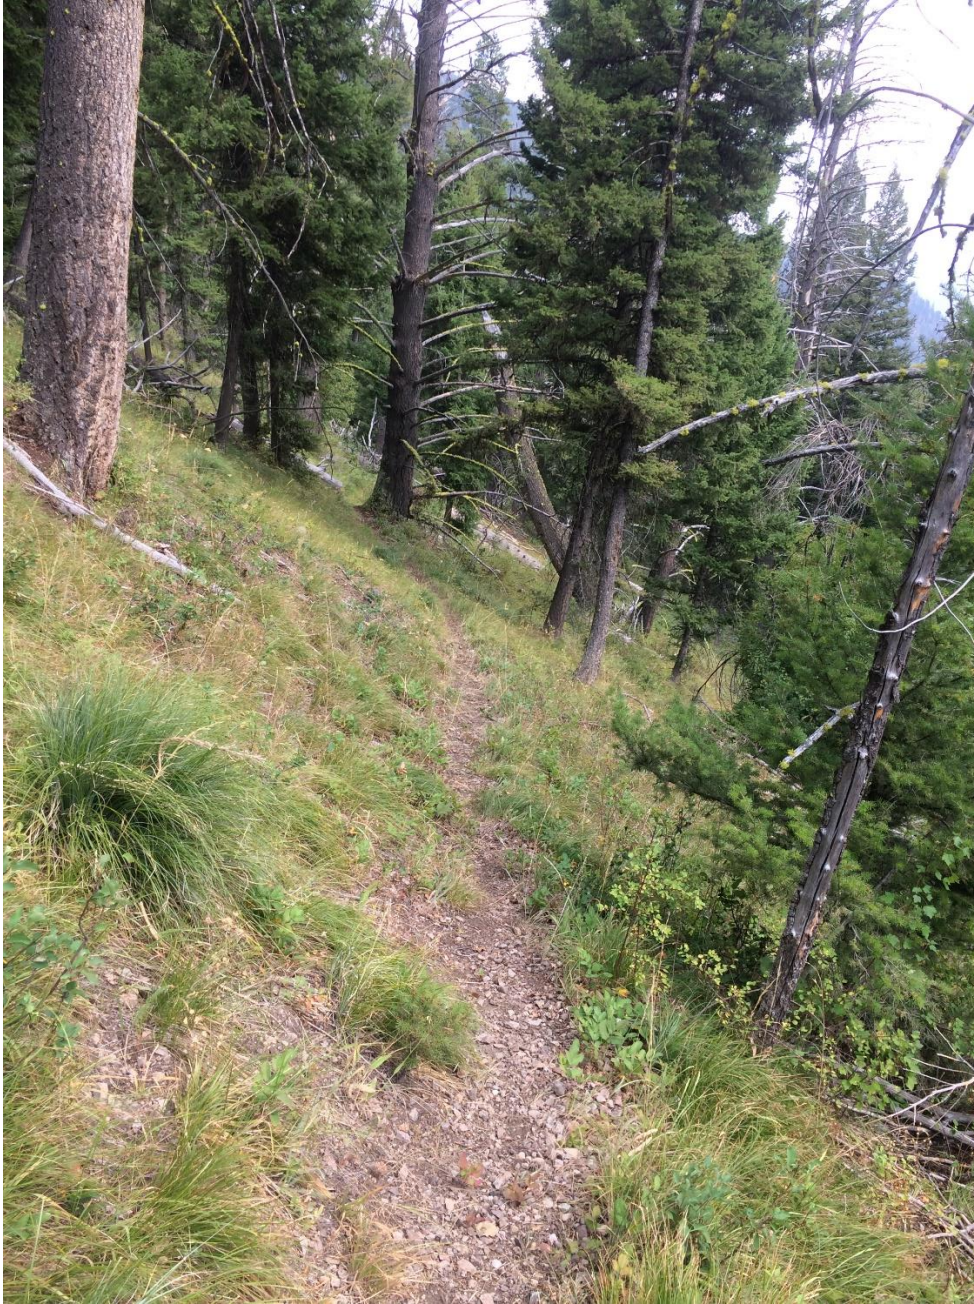
Twin Creek: Trail Creeping

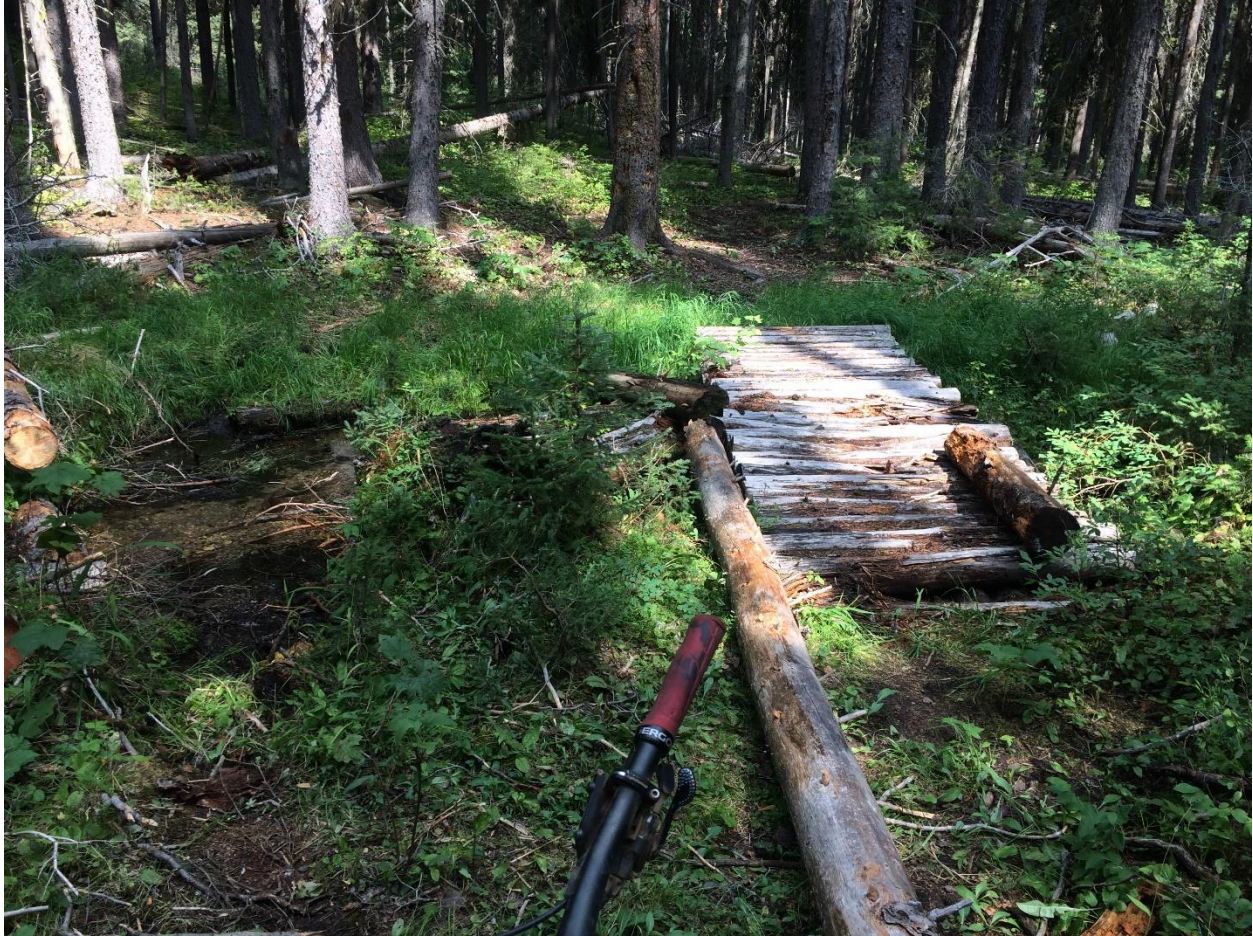
Twin Creek: This bridge is rotted. Users have been passing to the left. The creeks' banks are soft. Without armoring, the banks can break down, detouring the water onto the trail. It is recommended that all creek crossings have armored banks to help keep the water in its channel.

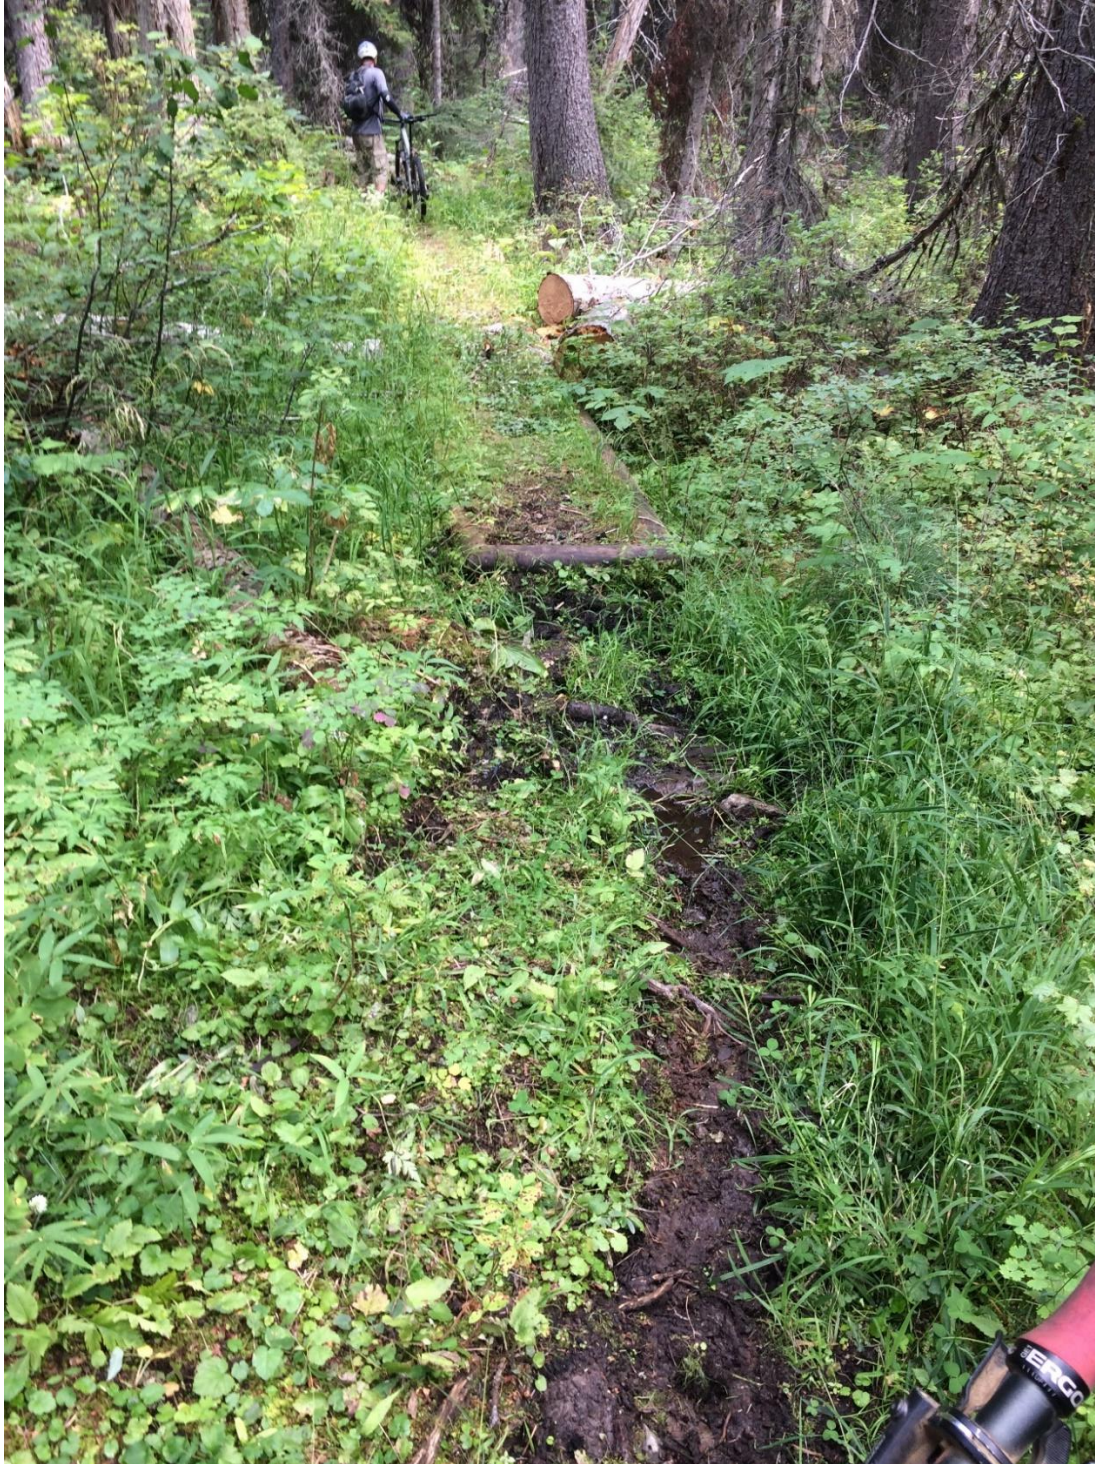
Twin Creek: These turnpikes are short segments through this area. There needs to be a consistent turnpike with drain features in order to reduce the impacts of the riparian area. These turnpikes are found in the same area as the bridge.

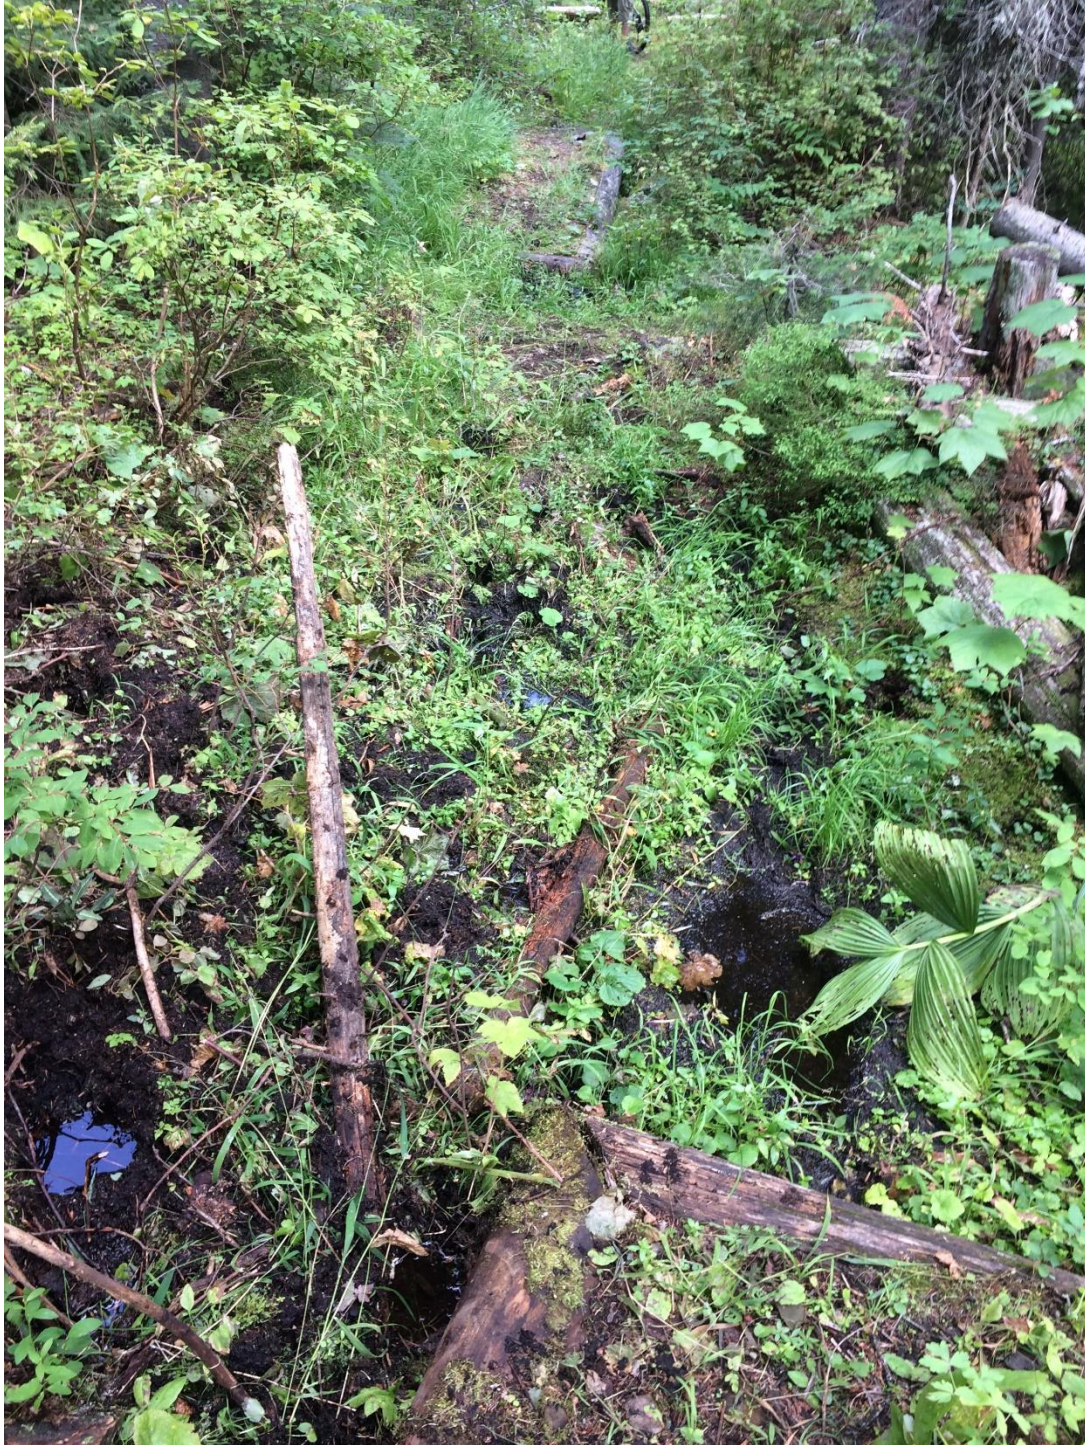
45.6257 -114.0251  
LATITUDE LONGITUDE

Twin Creek Turnpikes; These turnpikes are found in the same area as the bridge.

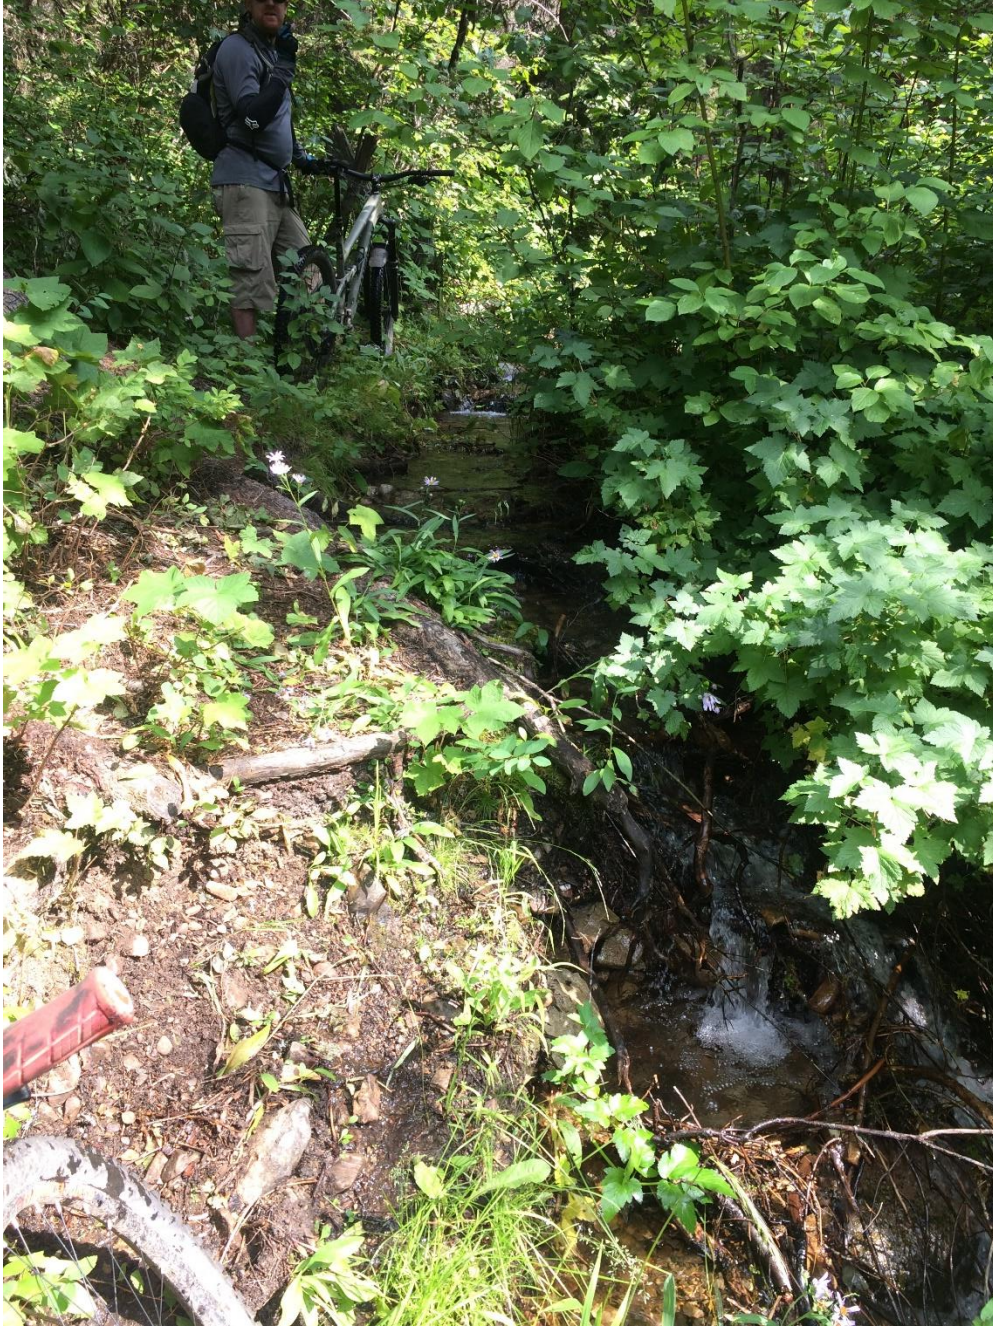
45.6246 -114.0212  
LATITUDE LONGITUDE

Twin Creek: This creek flows in both directions of the trail. The Riparian vegetation is thick, blocking the water from flowing across the trail. The vegetation needs to be cut back and the old creek channel cleaned out for proper flow.

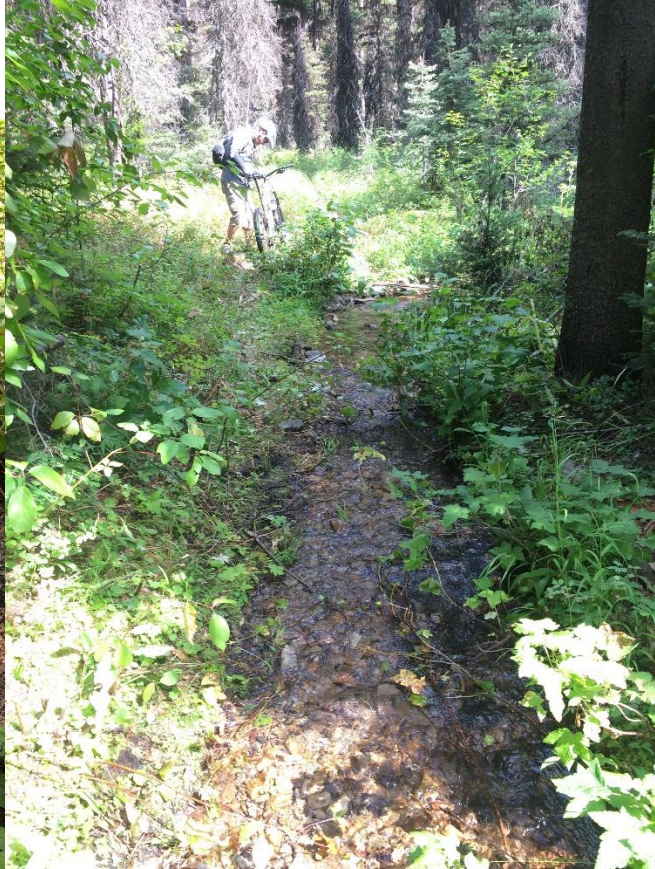
45.6246 -114.0212  
LATITUDE LONGITUDE

Twin Creek, just below the turnpikes. Creek flowing on the trail for about 100 feet.

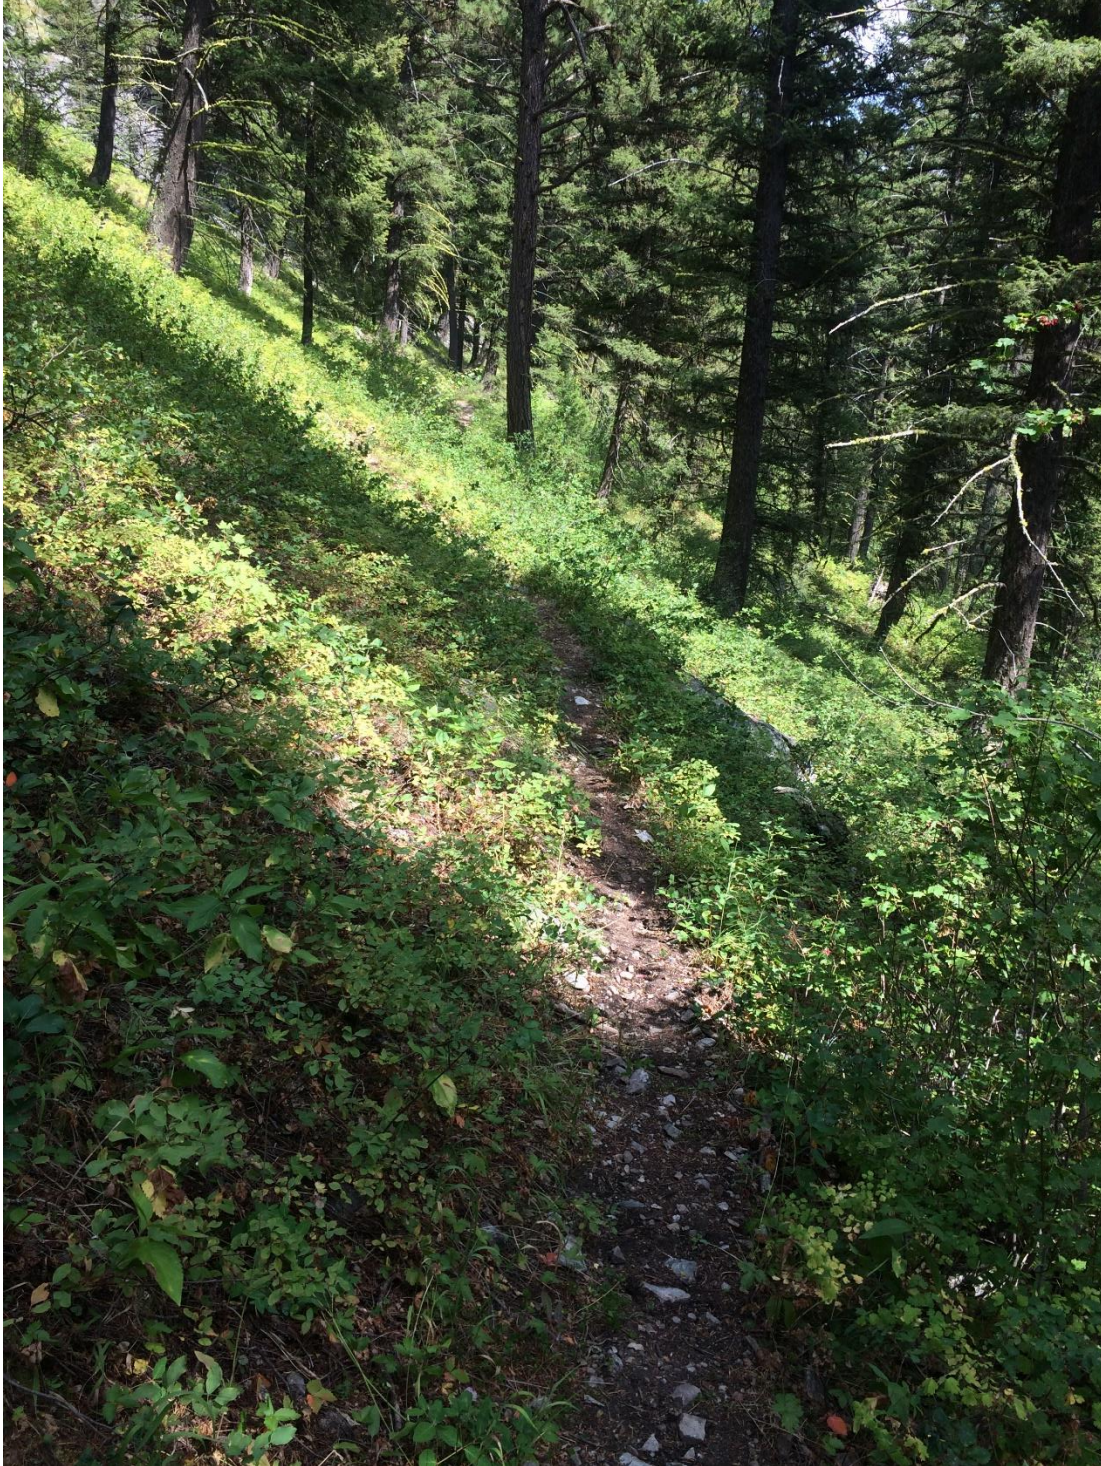
45.6204 -114.0095  
LATITUDE LONGITUDE

Twin Creek: Trail-creeping has narrowed this section of trail. The side-hill trail will need to be Dug-out so users can travel on a solid tread.

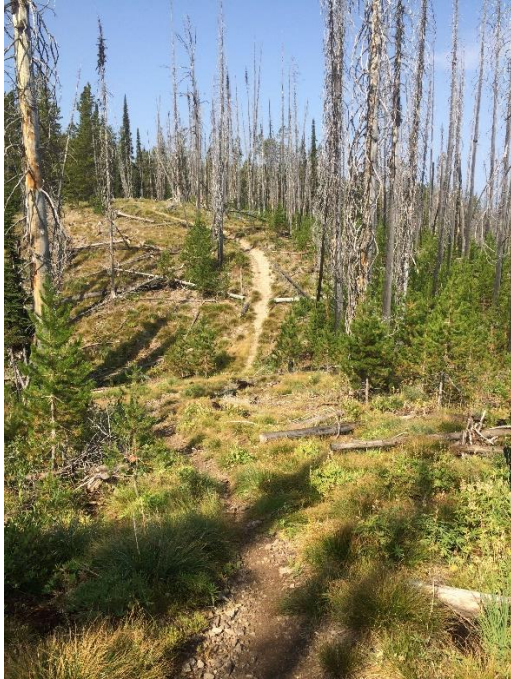
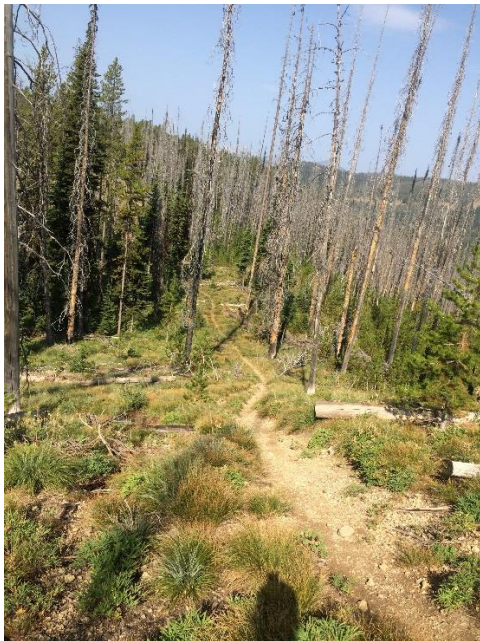
Divide 6106; fall -line trail that is about 1200 feet long.

All the trail issues are the same; fall-line trail with little or no drain features, creating trail-braids and deep trenches in the trail. The photos will start from Lost Trail and head south to Twin Creek. There are about 11 sections that are fall-line trails with braiding, trenching, or both.

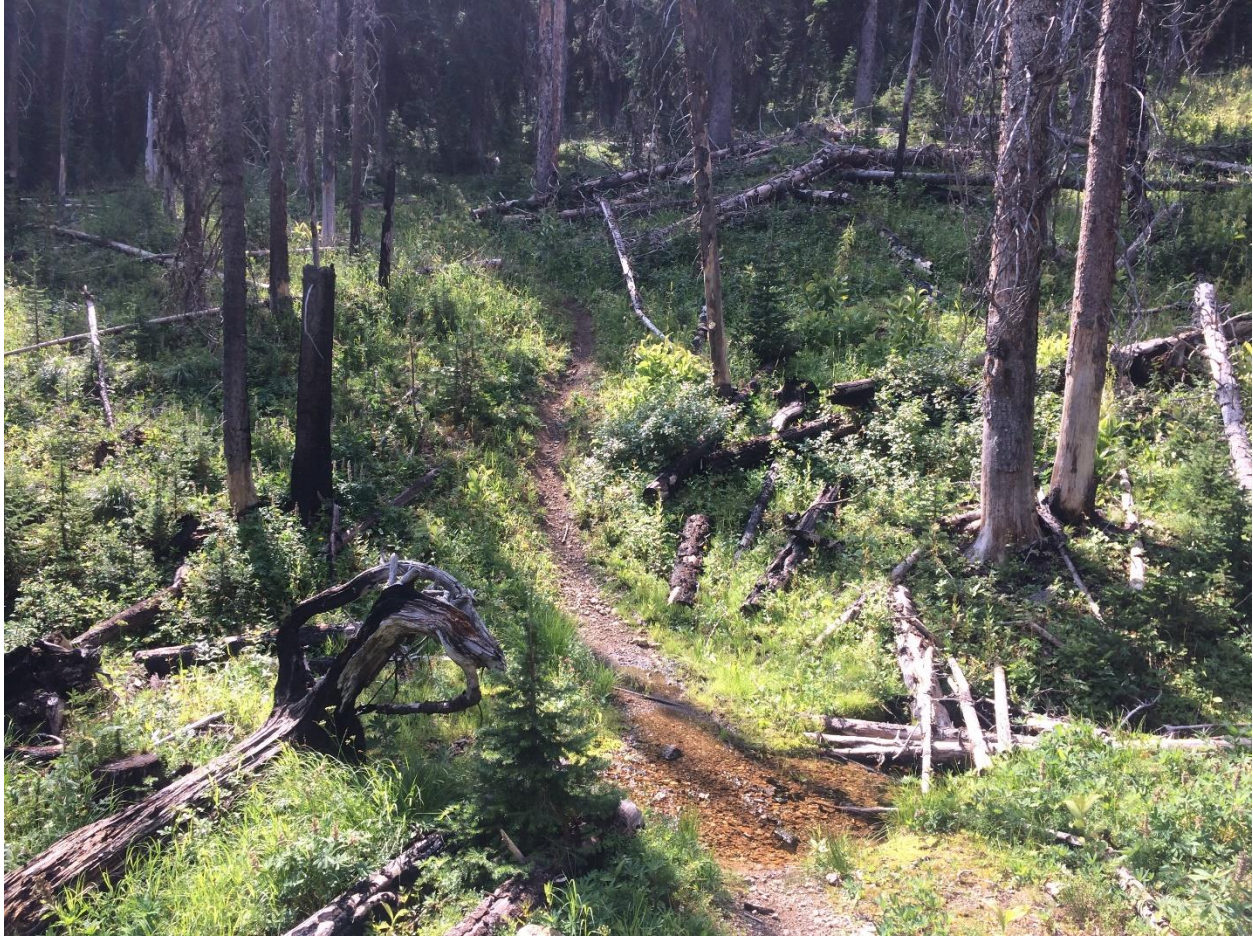
Divide 6106; All three locations have trail baiding and rutting/Trenching

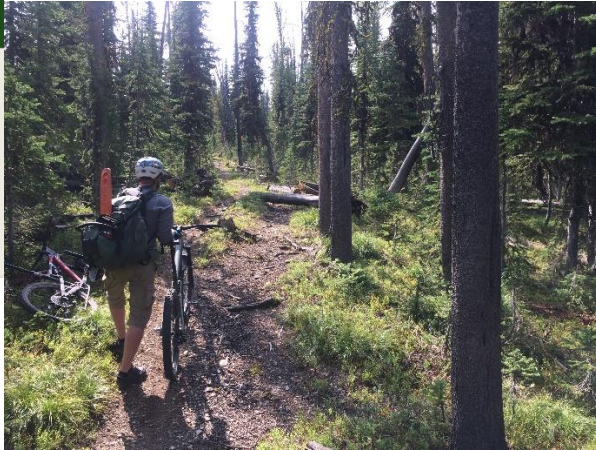
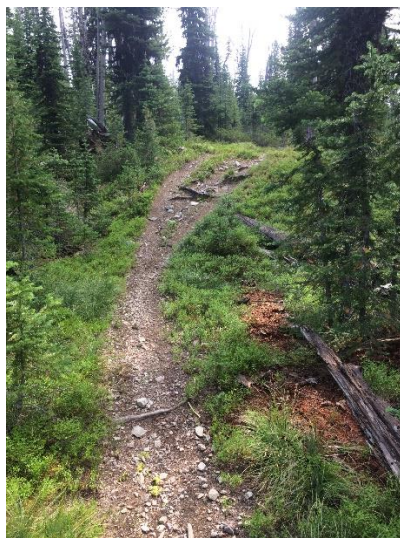
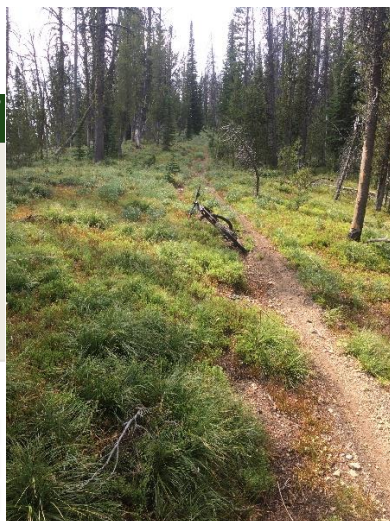
Divide 6106; This is all one location. Its between Twin Creek Ridge 6109 and Twin Creek 6108
