**2L Trails**  
**Trail Volunteer Project Report for 2018**  
**Salmon/ Challis National Forest**

## 2L Trails 2018 Volunteer Report, S/CNF

### Williams Creek Trail Project (078) June 1-3, 2018

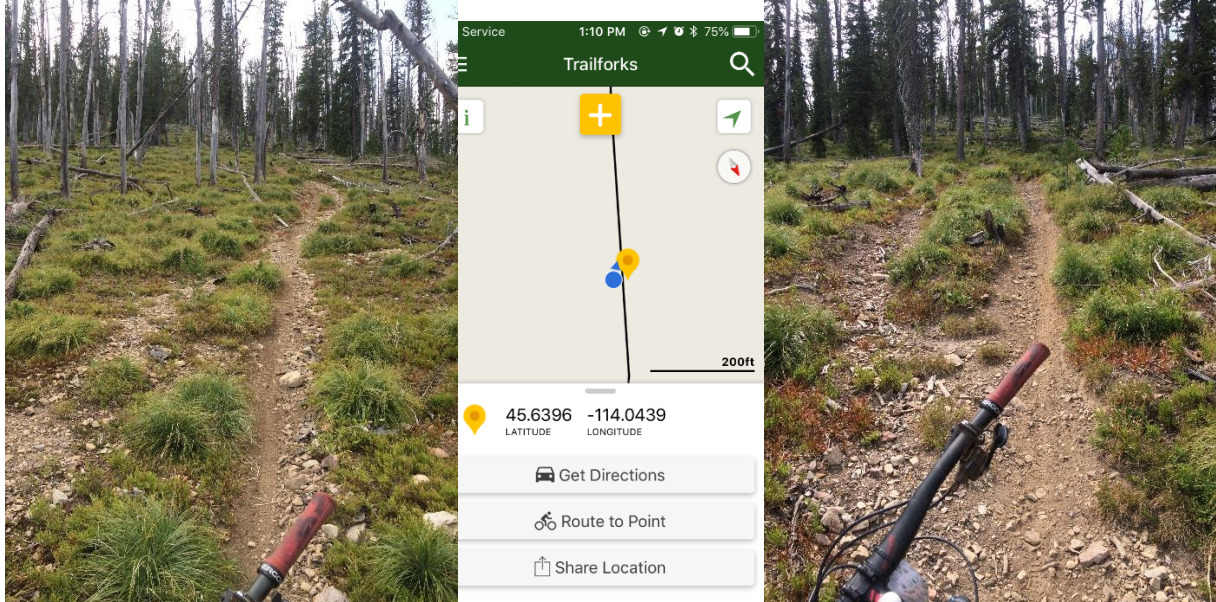
Divide 6106; This is all one location. Its between Twin Creek Ridge 6109 and Twin Creek 6108

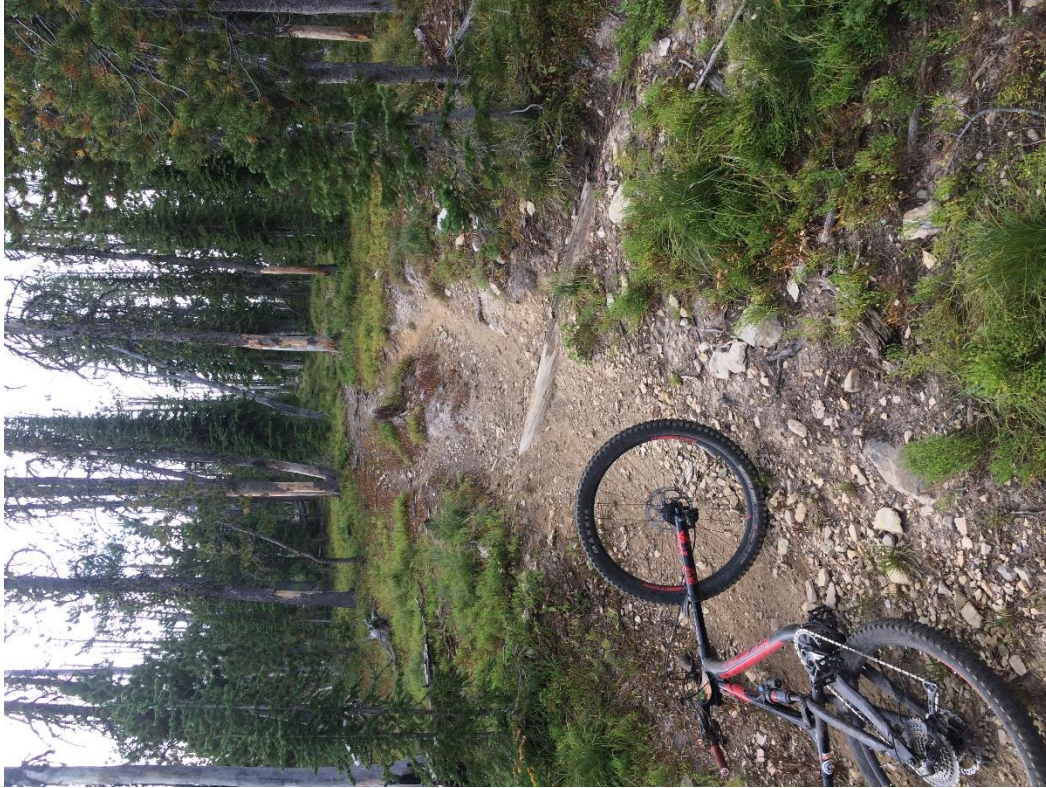
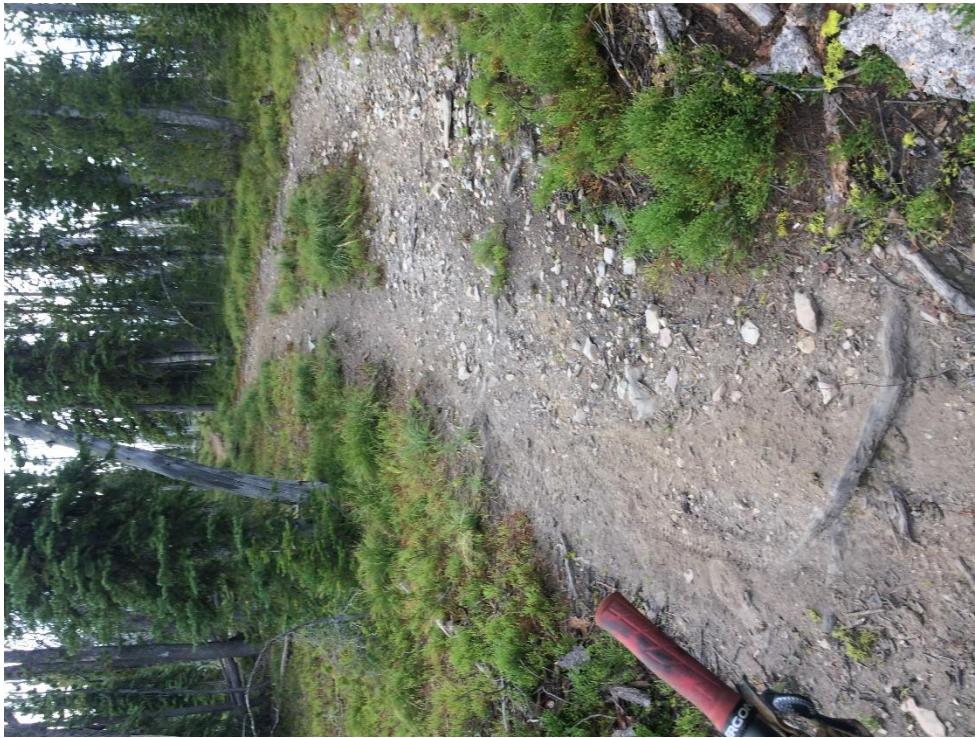
Divide 6106; Same location between Twin Creek Ridge and Twin Creek

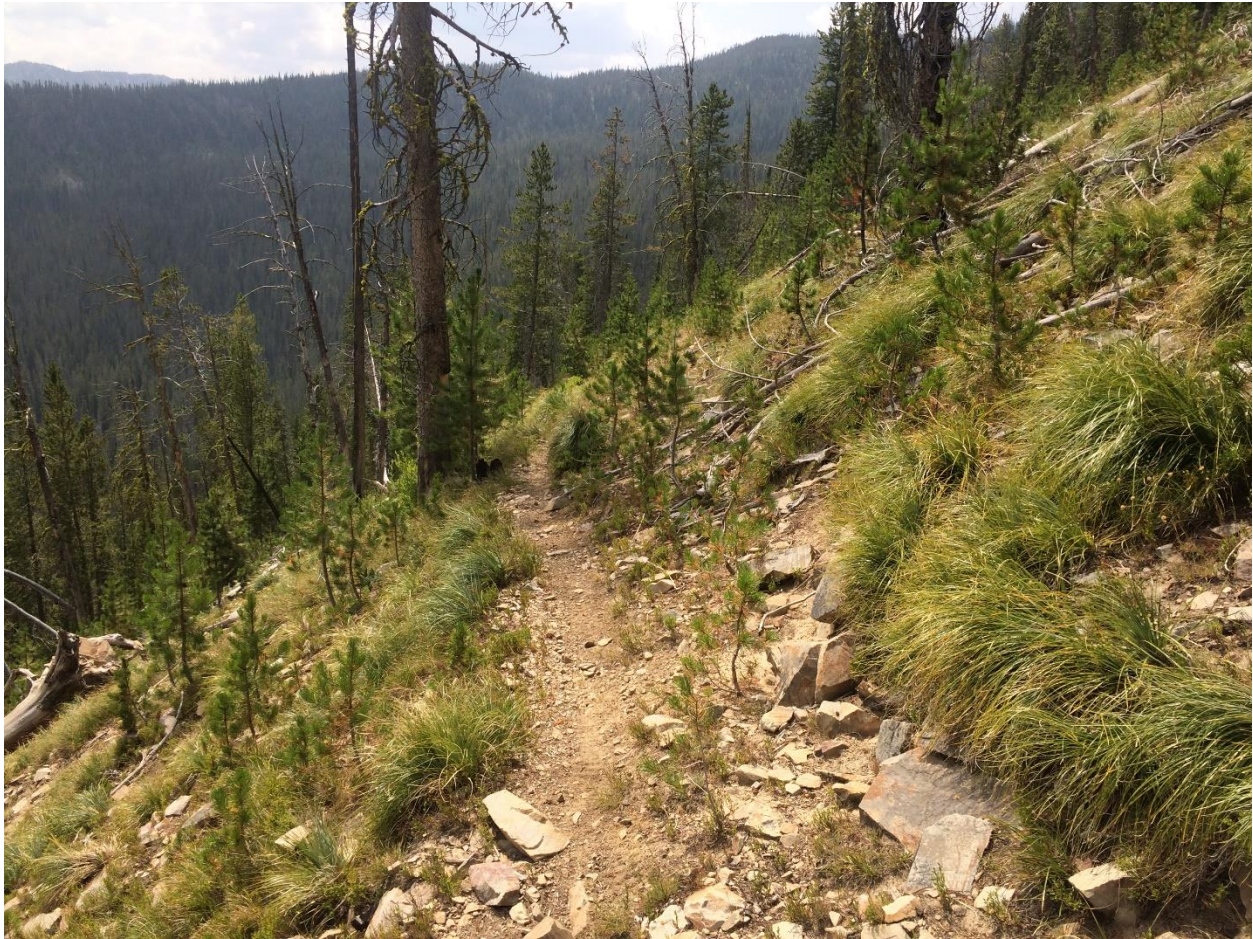
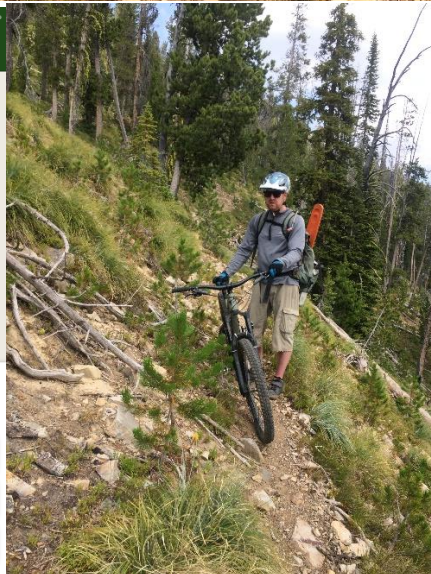
Divide; This is North of the junction for Twin creek 6108. The side-hill trail needs to be re-dug. Trail-creeping has made it narrow, forcing users to travel on the berm.

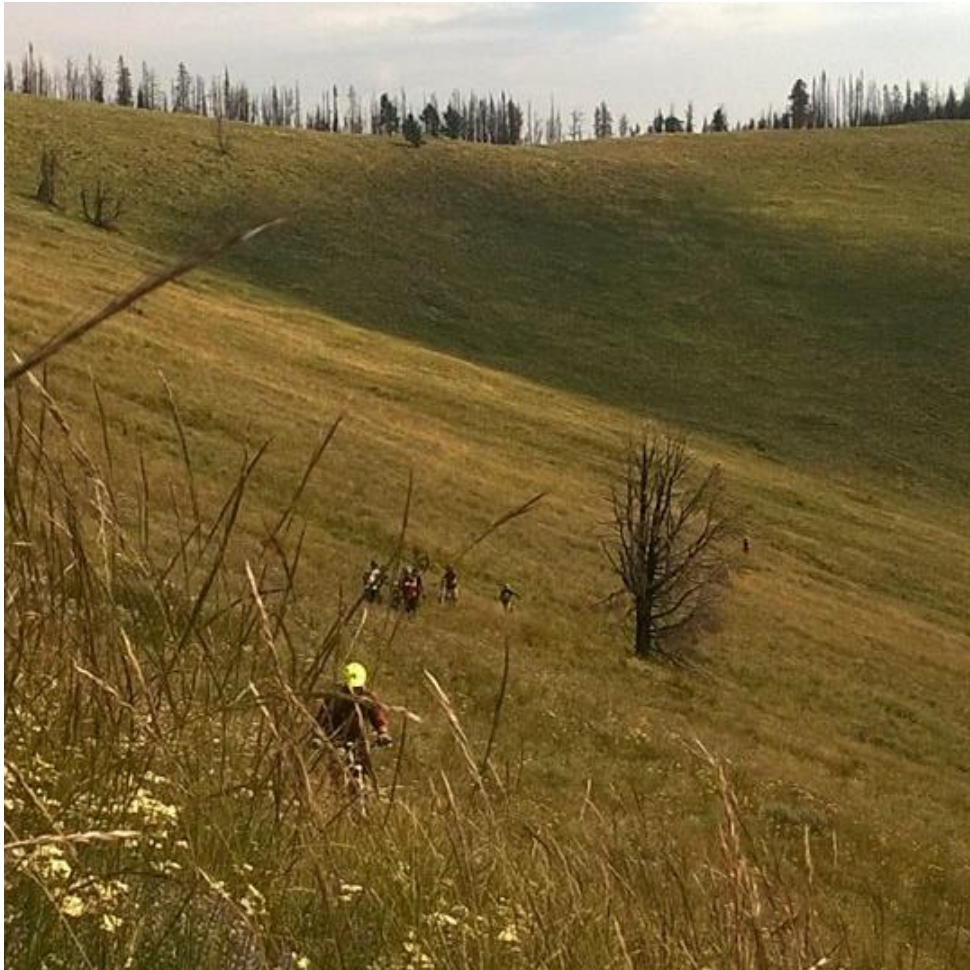
**Tin Can Springs 6213;** This non-motorized trail connects Butcher Knife Ridge to Henderson ridge, eliminating the steep climb to the Divide trail. It is also a water source for trail users and wildlife. Tin Can is used mostly by mountain bikers to access the Divide trail without climbing up the steep grade at the top of Butcherknife. Only half the trail is visible due to trail creeping and lack of use. There are a few locations where the side hill trail is too steep. It is recommended that the trail be restored by digging out the sloughing material on the existing trail bench, realignments in places where the grade is too steep, and cut a tread into open areas that will give the trail continuity.
